2012 Chevrolet Cruze

Structural Analysis *(Rocker Panel)*

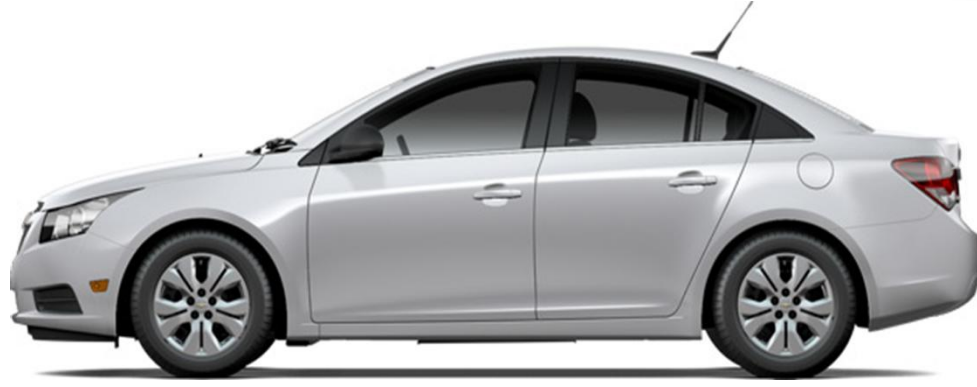
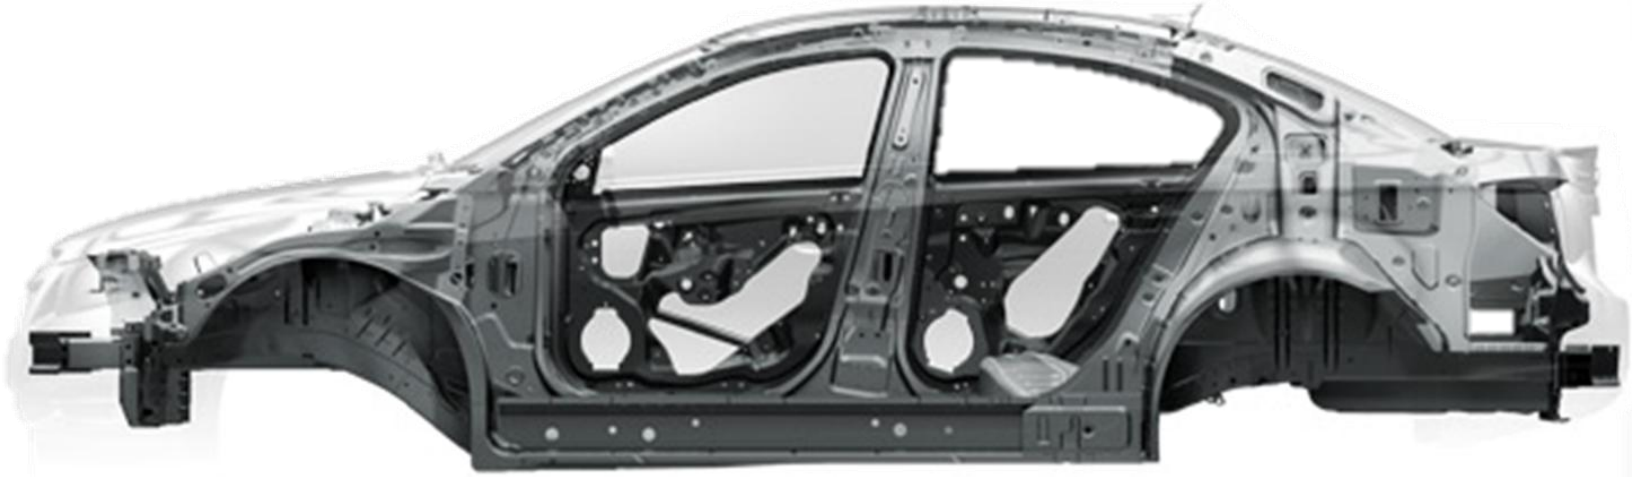
Rocker Assembly

- Structure type is unitized (Unibody)
- Structural design does not differ across various trim packages.
- Area of concern no different than majority of unitized structures.
- Rocker panel assembly consists of both 'inner' and 'outer' sheet metal.

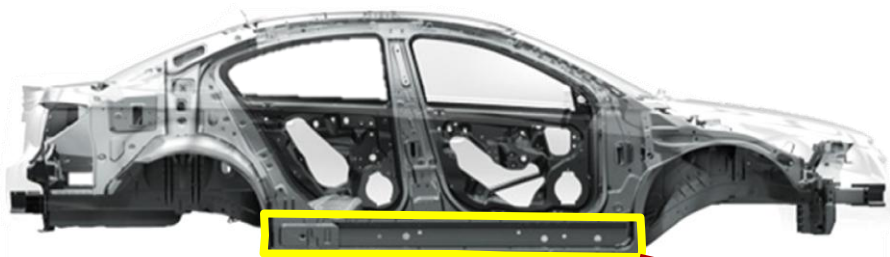
*Left inner
rocker panel*

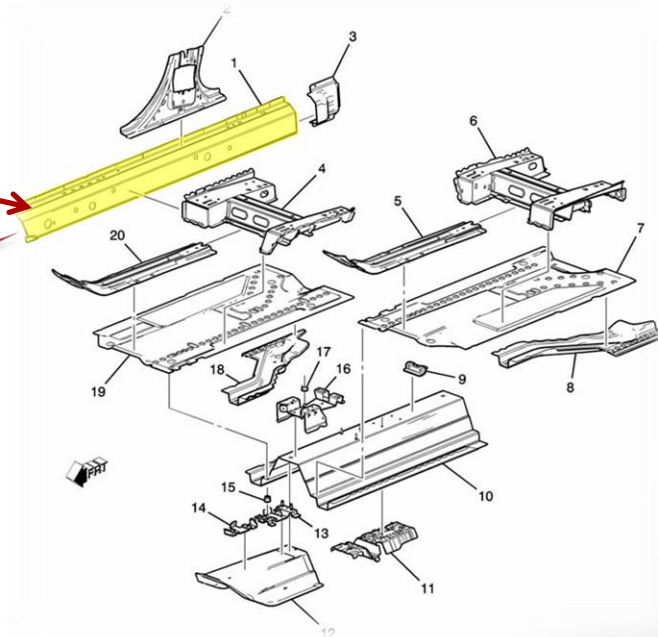
*Right Outer
rocker panel*

*Right Inner
rocker panel*

*Pinch weld
(connects rocker panels)*

*Floor Pan
Assembly*

LT model pictured (courtesy of Hendrick Chevrolet of Gwinnett)

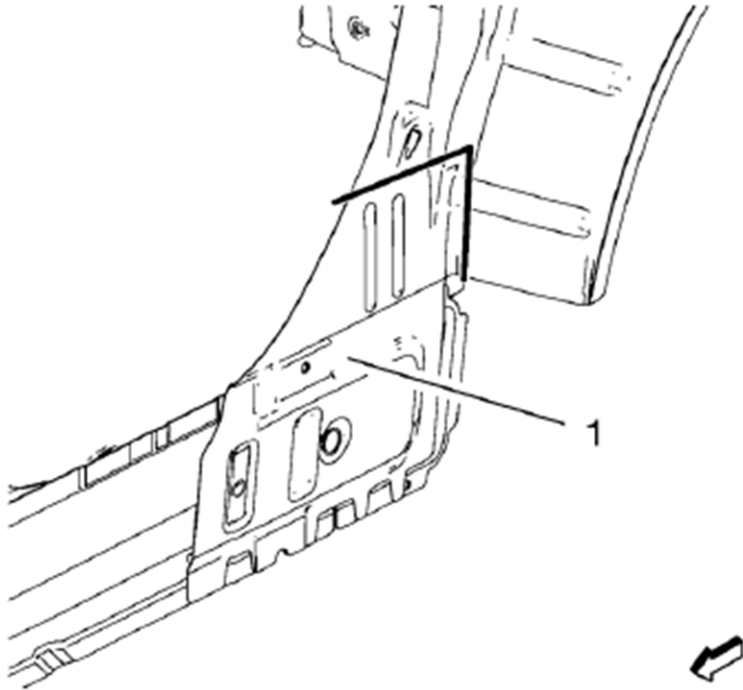
Inner Rocker Remove and Replace

1. Disable the SIR System. Refer to [SIR Disabling and Enabling](#).
2. Disconnect the negative battery cable. Refer to [Battery Negative Cable Disconnection and Connection](#).
3. Remove all related panels and components.
4. Visually inspect the damage. Repair as much of the damage as possible.
5. Remove the sealers and anti-corrosion materials from the repair area, as necessary.

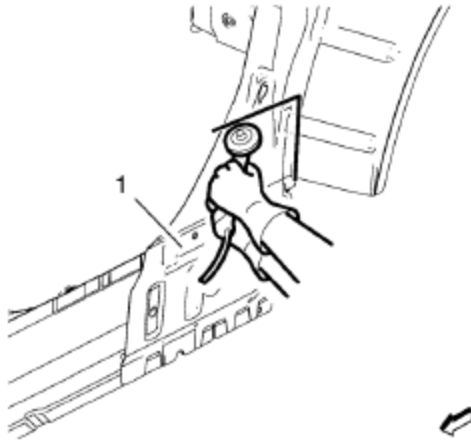
6. Create cut lines on the body side inner panel (1).

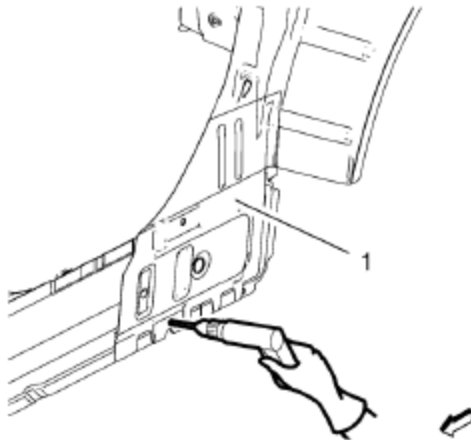
Note: Do not damage any inner panels or reinforcements.

7. Cut the body side inner panel (1) where sectioning is to be performed.

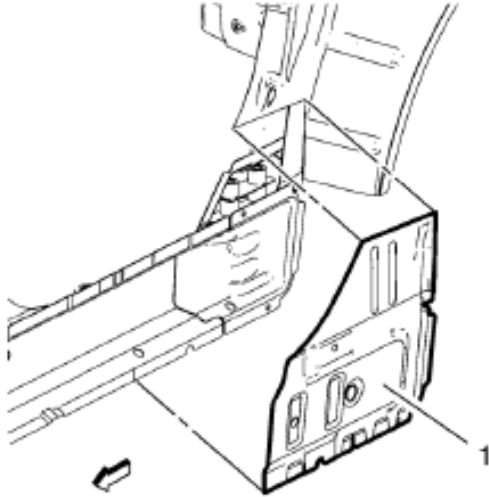
8. Locate and mark all the necessary factory welds of the body side inner panel (1).
9. Drill all factory welds. Note the number and location of welds for installation of the service assembly.

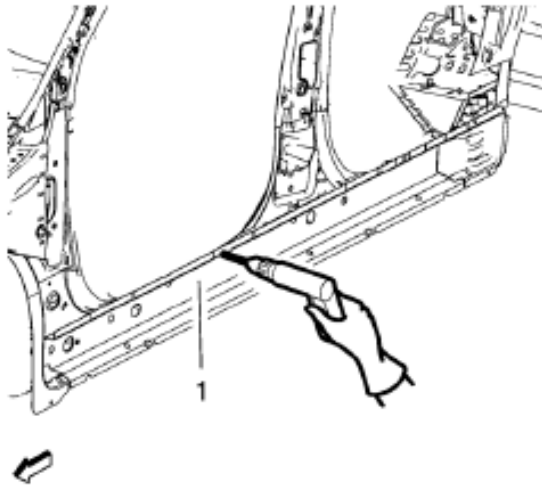
10. Remove the body side inner panel (1).

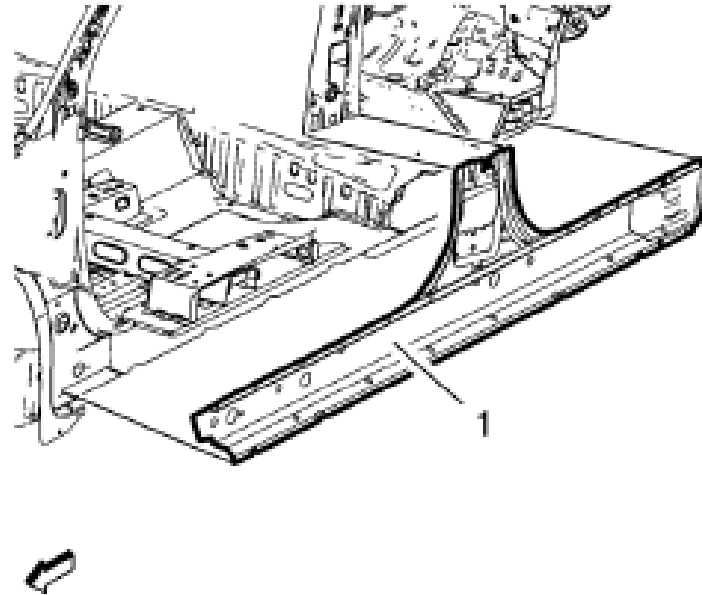
11. Locate and mark all the necessary factory welds of the rocker inner panel (1).
12. Drill all factory welds. Note the number and location of welds for installation of the service assembly.

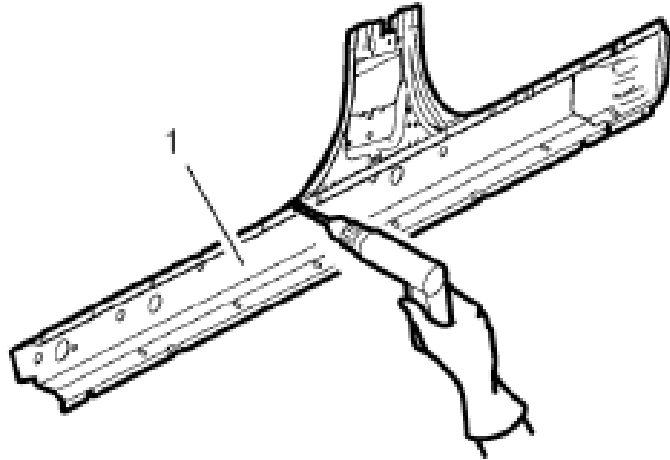
1. Align the rocker inner panel.

2. Drill 8 mm (5/16 in) for plug welding along the edges of the rocker inner panel (1) as noted from the original panel.
3. Clean and prepare the attaching surfaces for welding.
4. Position the rocker inner panel on the vehicle.
5. Verify the fit of the quarter outer panel.

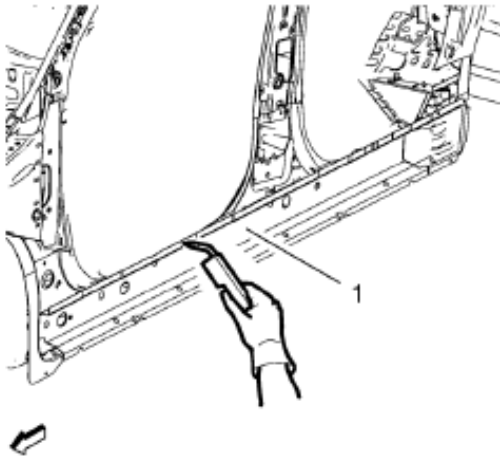
6. Clamp the rocker inner panel into position.

7. Plug weld the rocker inner panel (1) accordingly.

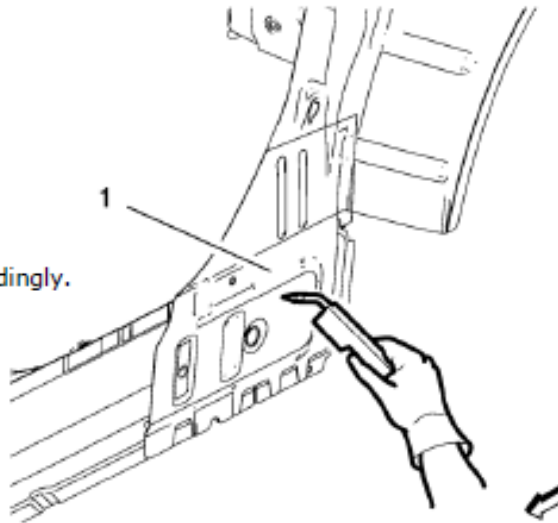
8. Plug weld the body side inner panel (1) accordingly.
9. To create a solid weld with minimum heat distortion, make 25 mm (1 in) stitch welds along the seam with 25 mm (1 in) gaps between them. Then go back and complete the stitch weld.
10. Apply the sealers and anti-corrosion materials to the repair area, as necessary. After repair and/or replacement parts are installed, all accessible bare metal surfaces must be treated with metal conditioner and reprimed.
11. Paint the repaired area. Refer to [Basecoat/Clearcoat Paint Systems](#).
12. Install all related panels and components.
13. Connect the negative battery cable.
14. Enable the SIR system. Refer to [SIR Disabling and Enabling](#).

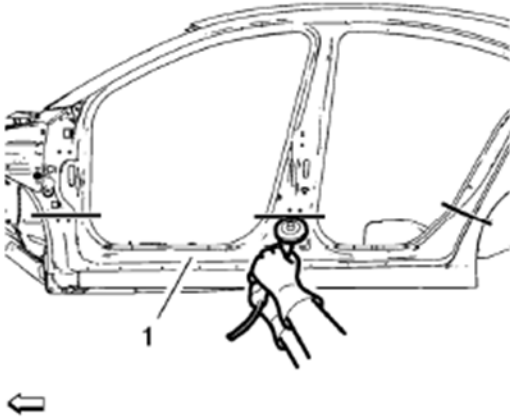
6. Create cut lines on the rocker outer panel (1).

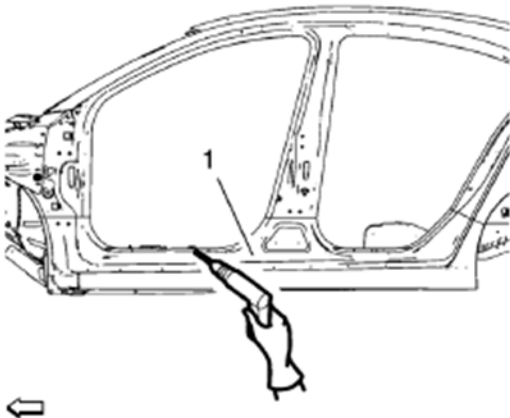
Note: Do not damage any inner panels or reinforcements.

7. Cut the rocker outer panel (1) where sectioning is to be performed.

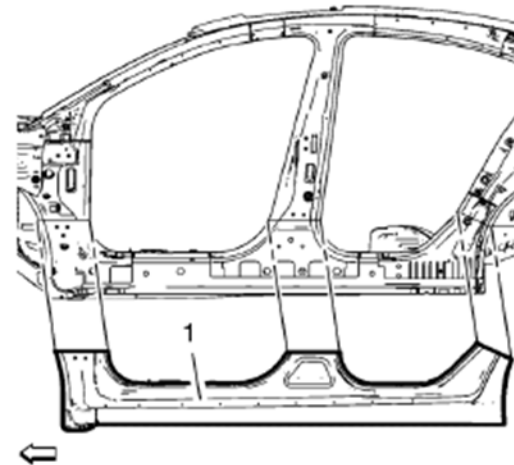
8. Locate and mark all the necessary factory welds of the rocker outer panel (1).

9. Drill all factory welds.

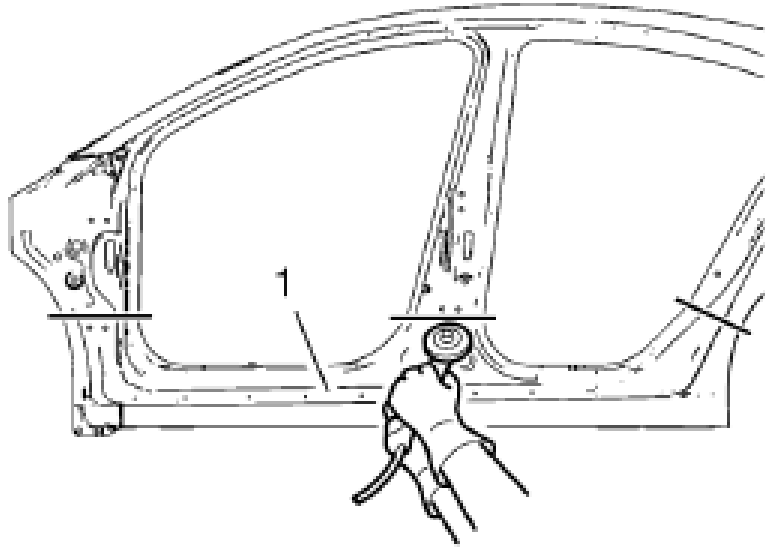
10. Remove the damaged rocker outer panel (1).

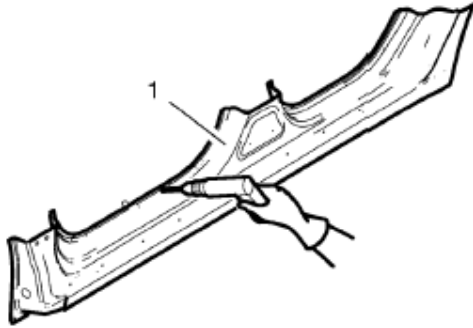
4. Prepare all mating surfaces as necessary.
5. Fit the backing plates halfway into the sectioning joints, clamp in place and weld to the vehicle.
6. Align the rocker outer panel.

7. Drill 8 mm (5/16 in) for plug welding along the edges of the rocker outer panel (1) as noted from the original panel.
8. Clean and prepare the attaching surfaces for welding.

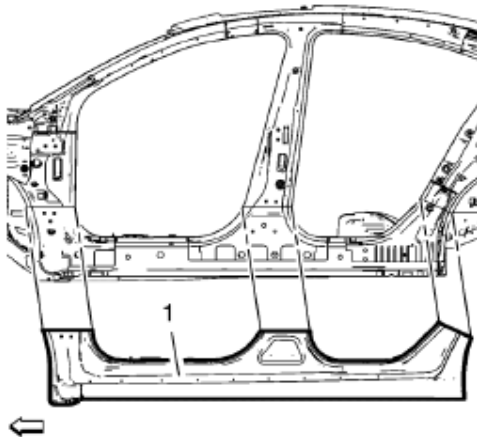
9. Position the rocker outer panel (1) on the vehicle.
10. Verify the fit of the rocker outer panel.

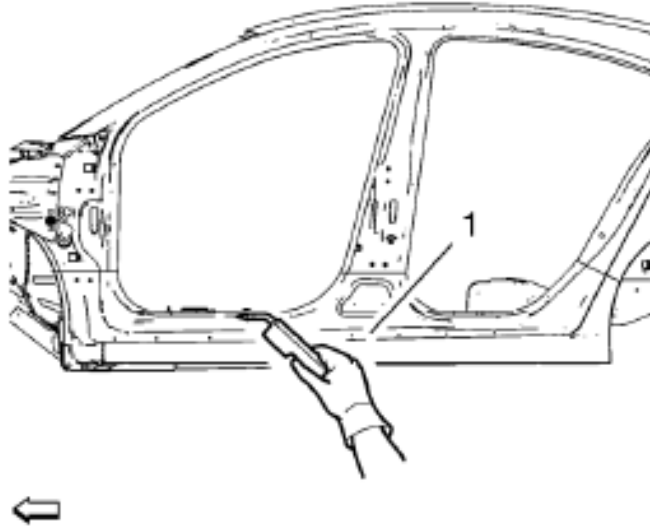
11. Clamp the rocker outer panel into position.

12. Plug weld the rocker outer panel (1) accordingly.
13. To create a solid weld with minimum heat distortion, make 25 mm (1 in) stitch welds along the seam with 25 mm (1 in) gaps between them. Then go back and complete the stitch weld.
14. Apply the sealers and anti-corrosion materials to the repair area, as necessary. After repair and/or replacement parts are installed, all accessible bare metal surfaces must be treated with metal conditioner and reprimed.
15. Paint the repaired area.
16. Install all related panels and components.
17. Connect the negative battery cable. Refer to [Battery Negative Cable Disconnection and Connection](#).
18. Enable the SIR system. Refer to [SIR Disabling and Enabling](#).
